TROUBLESHOOTING THE FLUID DRIVE OF A BOILER FEED PUMP

William Marscher and Eric Olson, Mechanical Solutions Inc

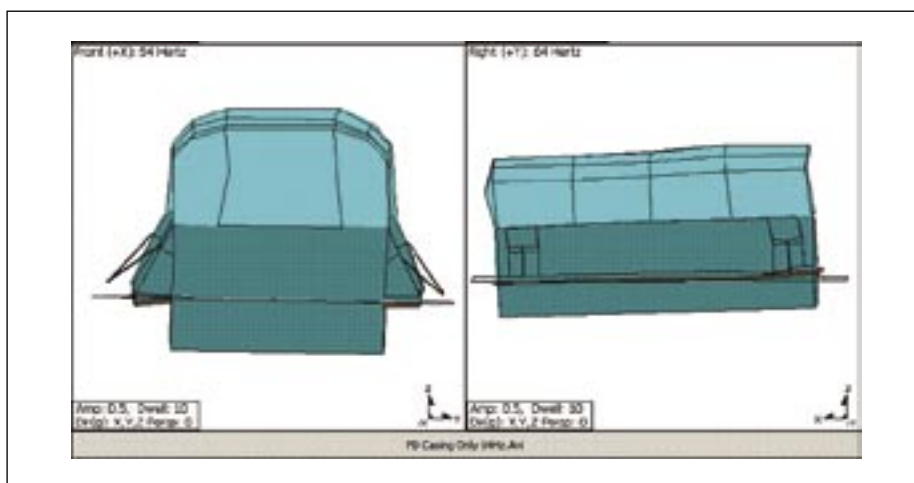
MSI's field testing was a combination of impact modal testing as well as operating forced response testing. Data for each of these tests was acquired at approximately 125 locations on the fluid drive, pump, front standard and foundation. The impact modal testing was used to determine the natural frequencies and mode shapes of the vibration while the plant operated. The operating forced response test data was used to produce the operating deflection shape (ODS) of the pump and drive assembly (Figure 1). A detailed

The operational testing indicated that the high vibration levels occurred at 60 hertz (Hz), and were primarily on the input end of the fluid drive and the front standard, peaking at a fluid drive output shaft speed of 2,500 rpm (42 Hz). However, the vibration levels on the output shaft were much higher at 60 Hz than at 42 Hz. The conclusion was that the high vibration levels at 60 Hz were primarily due to a torsional critical speed of the rotor system, which was able to "tune in" to

60 Hz as a function of the amount of oil in the fluid drive. The torsional stiffness of the fluid drive controlled the output shaft speed, which is why the vibration level appeared to be related (but indirectly as it turned out) to the output shaft speed. In addition, a structural natural frequency of the fluid drive bearing pedestals at about 64 Hz was clearly identified via ODS and modal testing. The rotor/structural combined vibration led to severe deterioration of the foundation below the fluid drive, to the point where the ODS and modal analysis animation showed that the sole plates were no longer integrally connected to the foundation, further magnifying the system vibration as is evident in Figure 1. The bearing pedestal natural frequency and foundation separation amplified the overall system shaking at 60 Hz, but the torsional critical speed was the root cause of the problem.

Figure 1: freeze-frame picture from an exaggerated-motion animation of the modal "bump" test performed while the pump train operated. Note the motion of the base of the fluid drive and sole plates relative to the concrete foundation.

The plant had to remain operational; therefore, a long-term fix involving the foundation was not a near-term option. To maintain power production, the customer used MSI's results to establish a strategy of avoiding fluid drive operation at 2,500 rpm to limit rapid bearing wear/failure and front standard deterioration. Permanent fixes to the foundation, along with modifications to the coupling and other shaft components to shift the problem torsional frequency, were laid out and planned for a future outage. <<
