TIMELINE OF A REFINERY PUMP FAILURE AND HOW IT COULD HAVE BEEN PREVENTED

By Todd Reeves, Machinery Health Management Business, Emerson Process Management

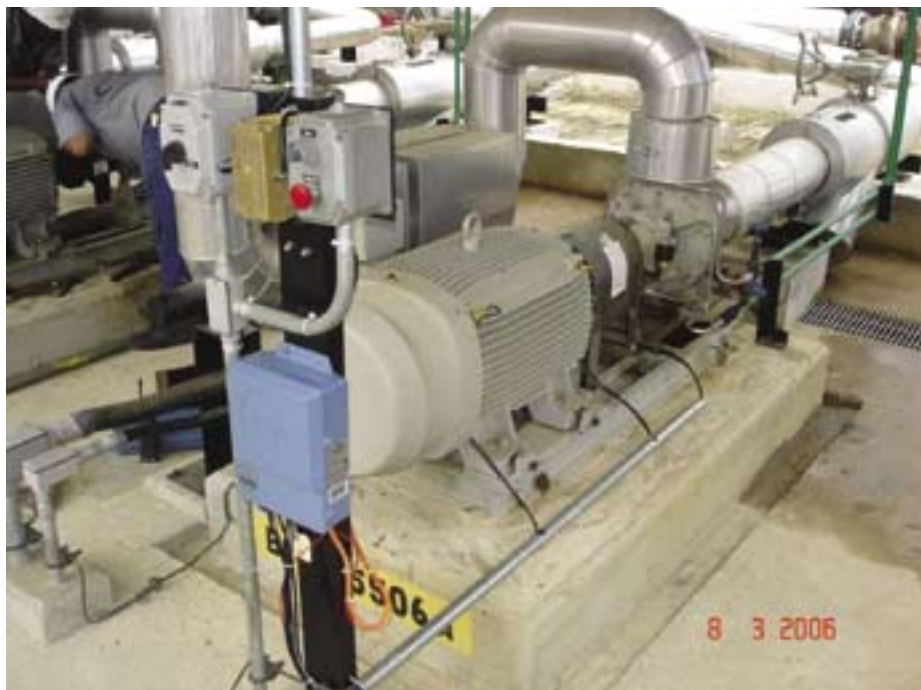
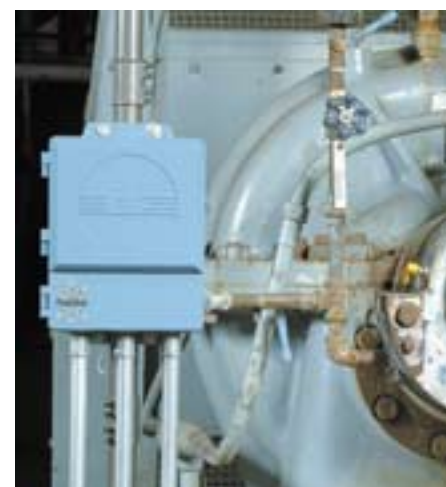
The CSI 9210 Machinery Health Transmitter installation at the refinery. Note the leads from sensors running back to the control box where microprocessor-based instrumentation gathers vibration and other data every 25 seconds for analysis and transmission via the refinery’s automation system.

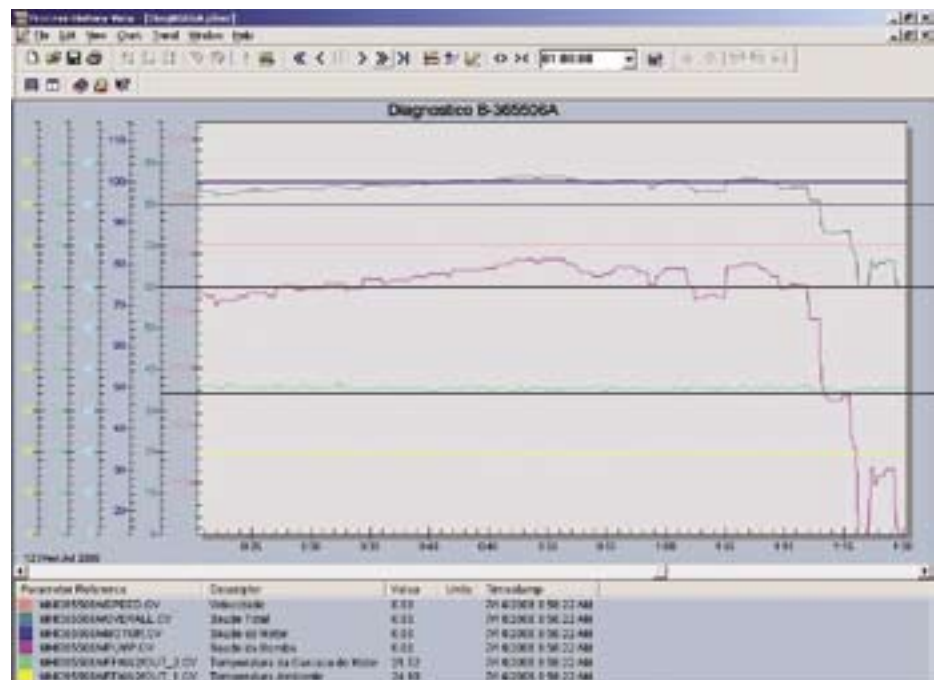
The failure mode lasted a few hours, during which emergency action could have been taken to avoid the shutdown. The pump health value trend shown in the figure above deteriorates rapidly from about 60 to 0 over the final 10 minutes. Once the pump was in that state, catastrophic failure occurred very quickly.

Final moments before the pump failure. The pump health value trend deteriorates rapidly from about 60 to 0 over the final 10 minutes. Once the pump was in that state, catastrophic failure occurred very quickly.

A thermistor installed on the pump bearing housing would have given an indication of the temperature being generated there so that more forceful warnings could have been communicated to the control room.

Finally, a means of prioritizing the alerts coming from the field will better identify those critical to the continued operation of the process so they can be addressed first.
